NORTH SHORE OF LAKE SUPERIOR REMEDIAL ACTION PLANS

Fish Habitat in the Thunder Bay AOC

April 17th, 2019

Robert Stewart, Reg Nelson and Michelle Willows
Lakehead University

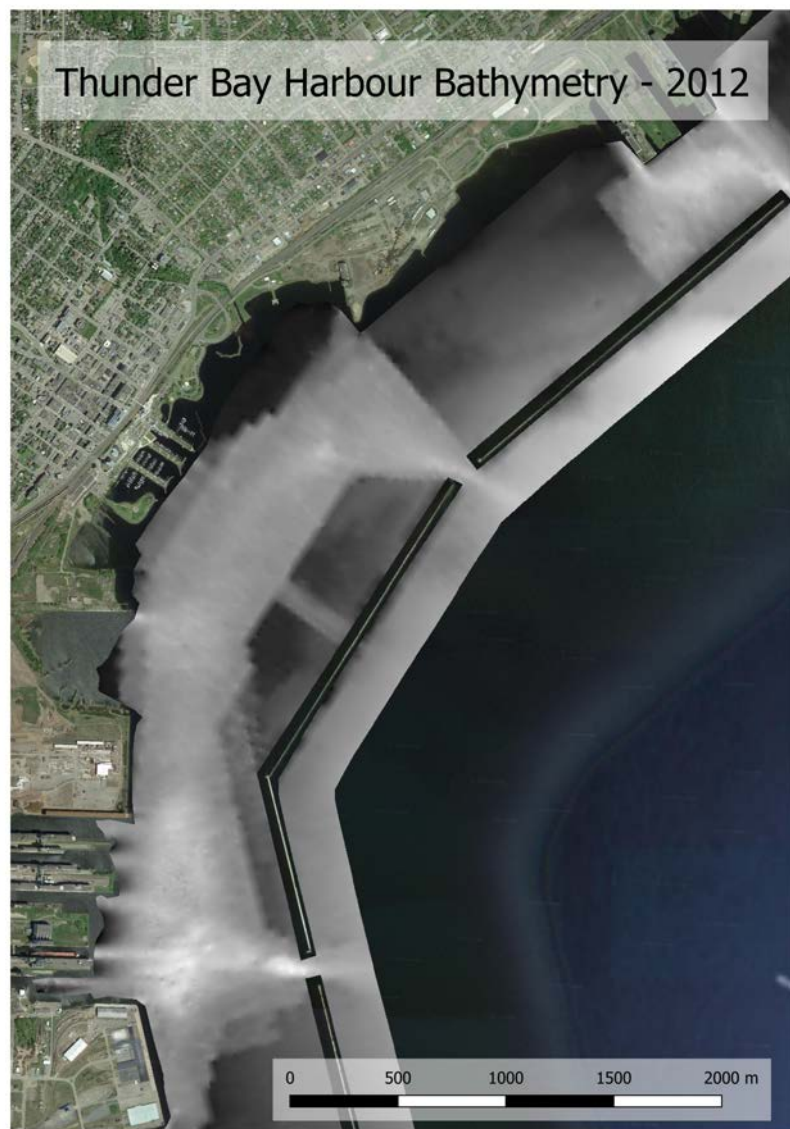
Thunder Bay Harbour Bathymetry & Substrate – 2012

Reclassify Substrate to correspond with unique fish habitat classifications.

Important information on fish habitat quality and quantity can be determined by identifying and mapping the lakebed characteristics. Assessment of the availability and health of fish habitat in the AOC will indicate the success of previous habitat restoration projects in restoring this beneficial use. This project will provide information about the extent and quality of fish habitat in the form of a ground truthed dataset developed by EC and a summary report reviewed by the MNR. Milestones for this project include:

- Completion of monitoring field work for the assessment of the substrate, which will include examining components of cobble and gravel areas for sediment and/or organic material
- Classification and assessment of lake bottom (submerged) substrates to determine the amount of fish habitat for each life stage
- Creation of substrate and bathymetry maps that show fish habitat classification and availability

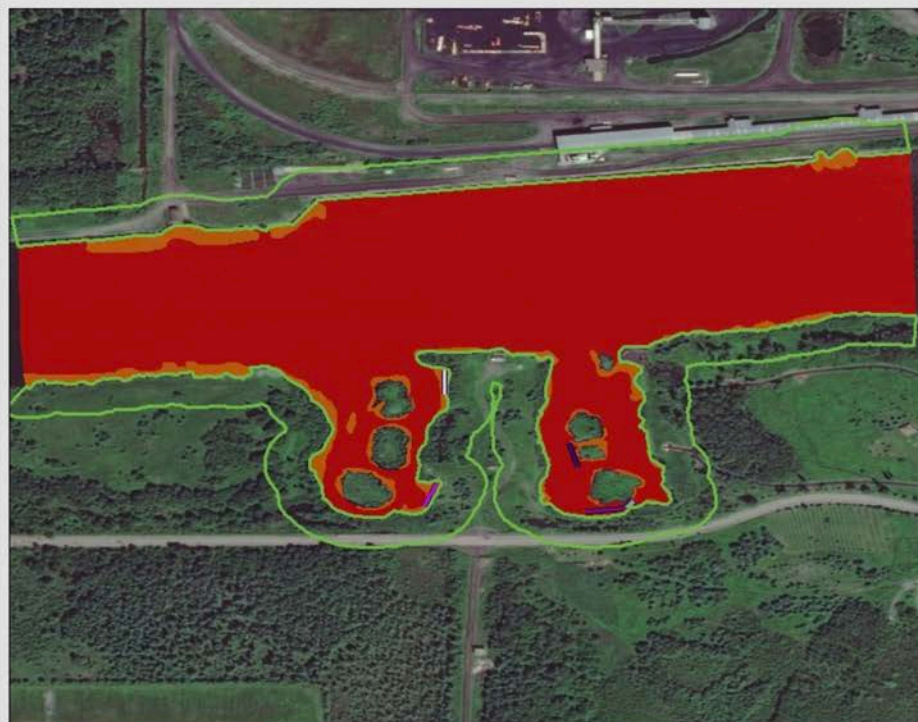
McKellar Embayments Submerged Aquatic Vegetation Cover, 2018

McKellar Embayments Ranking and Classification Based on Habitat Values			
Habitat Characteristics	Rating	Criteria	Score
WMI and Species Count	Moderate	- Neutral U Values (2-3) and T-Values (1-2) - Moderate Species Diversity, <10 species.	2
Species Density	Low	- Low density (Sparse = 1-25%) - Encrusting algae indicates low flow and stagnant conditions.	1
Substrate	Low	- The aquatic habitat is man-made with little sub surface complexity. - Sedimentation with within quiescent waters led to a fine grained, silty-loam substrate. - Banks are riprap and have a high gradient.	1
Water Quality	High	- Sustainable temperature 15-19.9 °C for diversification of species. - pH level range 6.5-7.5, ideal for aquatic biota. - High dissolved oxygen levels >7mg/L	4
Turbidity	Low	- High turbidity ranging from 35-54cm, detrimental to most aquatic biota. - Unfavourable to aquatic macrophytes due to lack of photosynthesis.	1

Habitat Buffer Zone	Moderate	- Meets the required 30m buffer, but otherwise surrounded by imperious surfaces, residential industrial activity.	3
Total Score			13
Habitat Ranking and Classification	Moderate Value: Important to the ecological functioning of the watershed or estuary. Direct contributions to fishery values are limited.

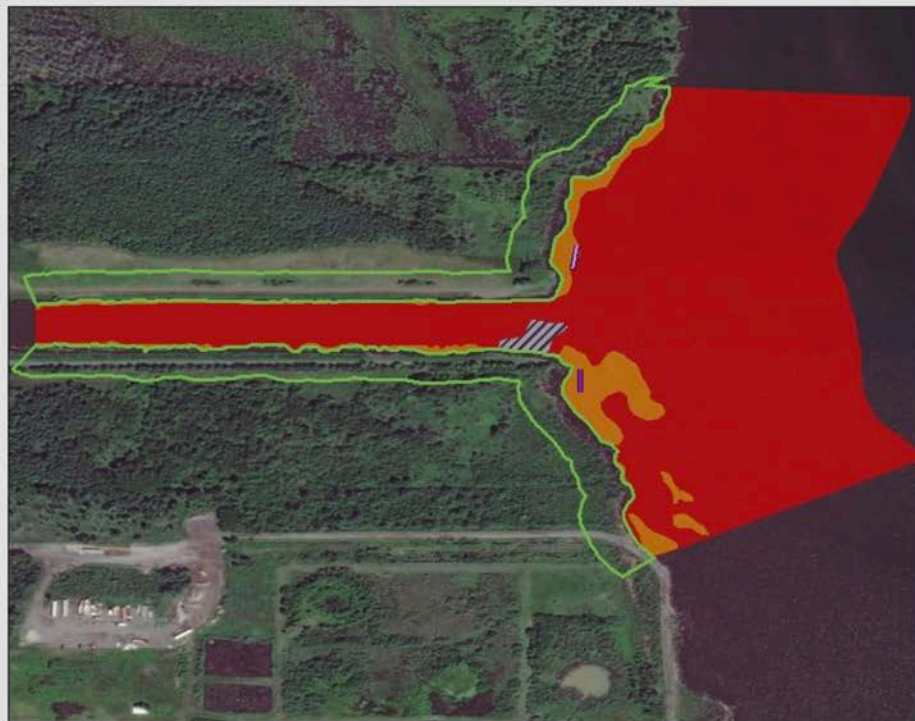
Neebing-McIntyre Floodway Submerged Aquatic Vegetation Cover, 2018

Neebing - McIntyre Ranking and Classification Based on Habitat Values			
Habitat Characteristics	Rating	Criteria	Score
WMI and Species Count	Low	<ul style="list-style-type: none"> - Low U Values (1) and T Values (1). - Low species diversity, <5 species. - Only 3 species encountered, that are typically have a high tolerance and broad niche. 	1
Species Density	Low	<ul style="list-style-type: none"> - Low density (Sparse = 1-25%), limited to a <2m strip within the littoral zone. 	1
Substrate	Low	<ul style="list-style-type: none"> - Silty-clay within the river channel, with sand along either side of the delta. - Substrates poor for vegetation rooting, limiting growth or stability due to its mobility in current and wave action. 	1
Water Quality	Moderate	<ul style="list-style-type: none"> - Sustainable temperatures 10-14.9 °C, ideal for pelagic fish, specifically the family Salmonidae. - pH remained neutral throughout the season, remaining slightly below 7.5. - Good dissolved oxygen levels 6g/L -7mg/L 	3

Turbidity	Low	<ul style="list-style-type: none"> - High turbidity ranging from 35-54cm, detrimental to most aquatic biota. 	1
Habitat Buffer Zone	Fair	<ul style="list-style-type: none"> - Close to achieving 30m minimum buffer, with patch's or gaps of missing vegetation due to brown zones. - Paved walkways along the stream can increase surface runoff. 	2
Total Score:			9
Habitat Ranking and Classification	Minimal Value: Habitat not considered important to ecological functioning of the watershed, with minimal fishery values. Limited contributions exist but are not sensitive to development.

Data derived from polygon
overlay of side-scan sonar
data collected in the summer
months of 2018.
Date: February 5th, 2019
By: Michelle Willows
